OAK TREE REPORT

Calabasas Kia

Date: March 31, 2023

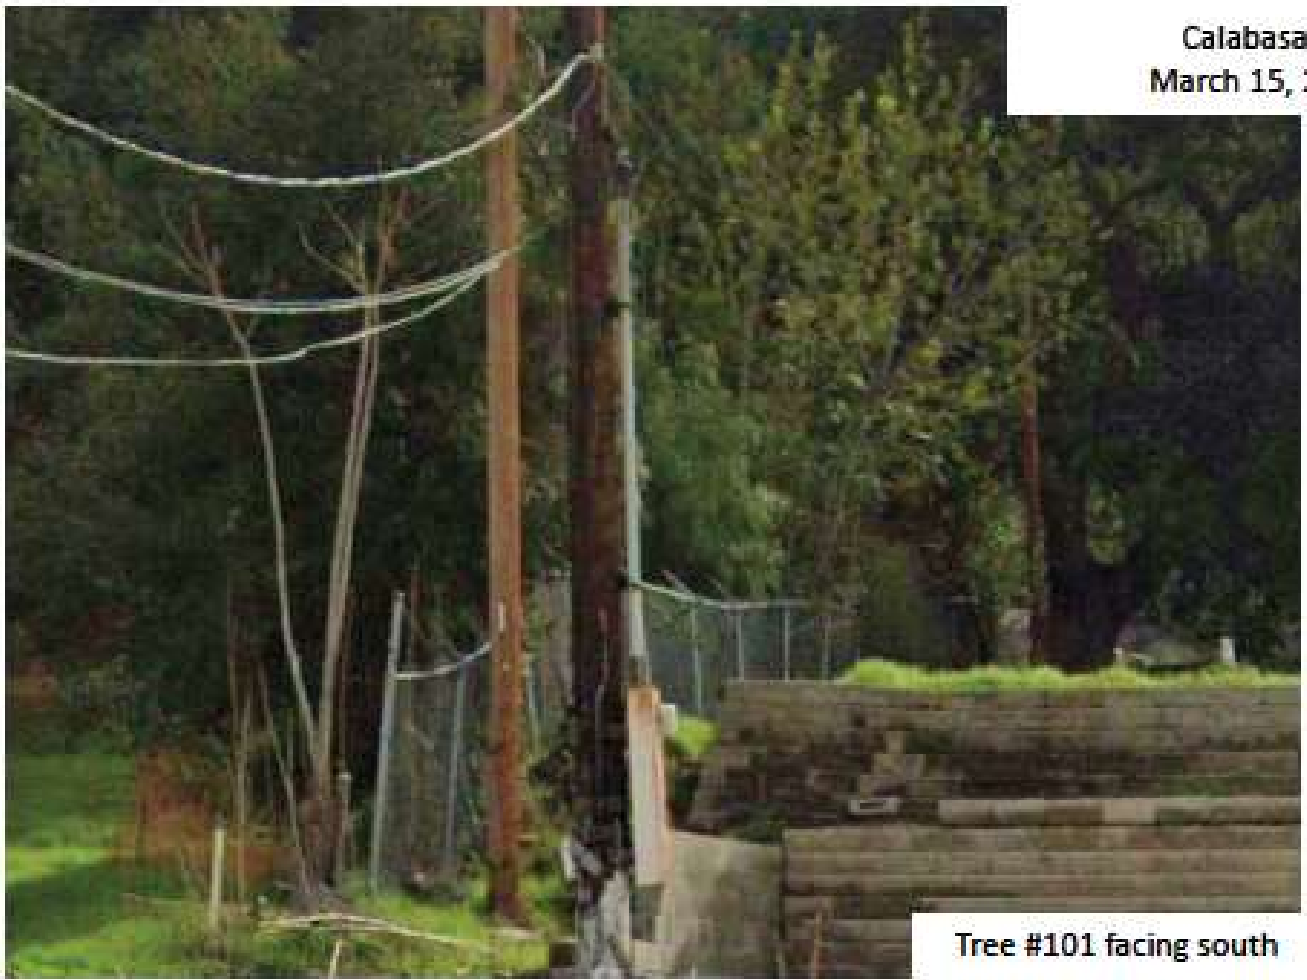
Tree #101 facing south

Oak tree #101 – This tree is on the property line and must be removed to build the 5-foot retaining wall, 5 feet from the proposed building.

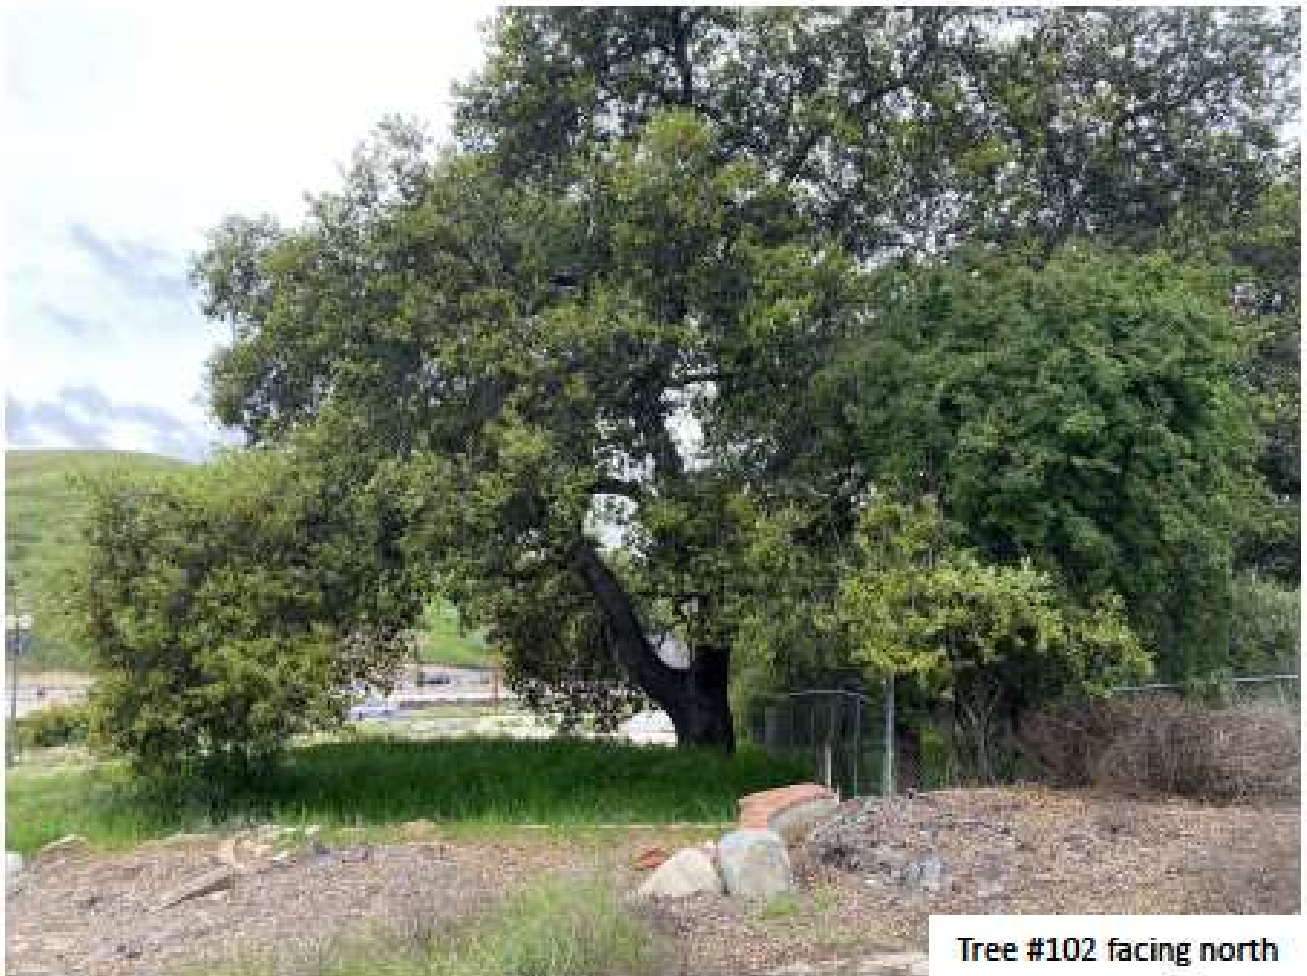
Tree #102 facing north

Oak tree #102 – This heritage tree is located 2 feet from the proposed building and must be removed.

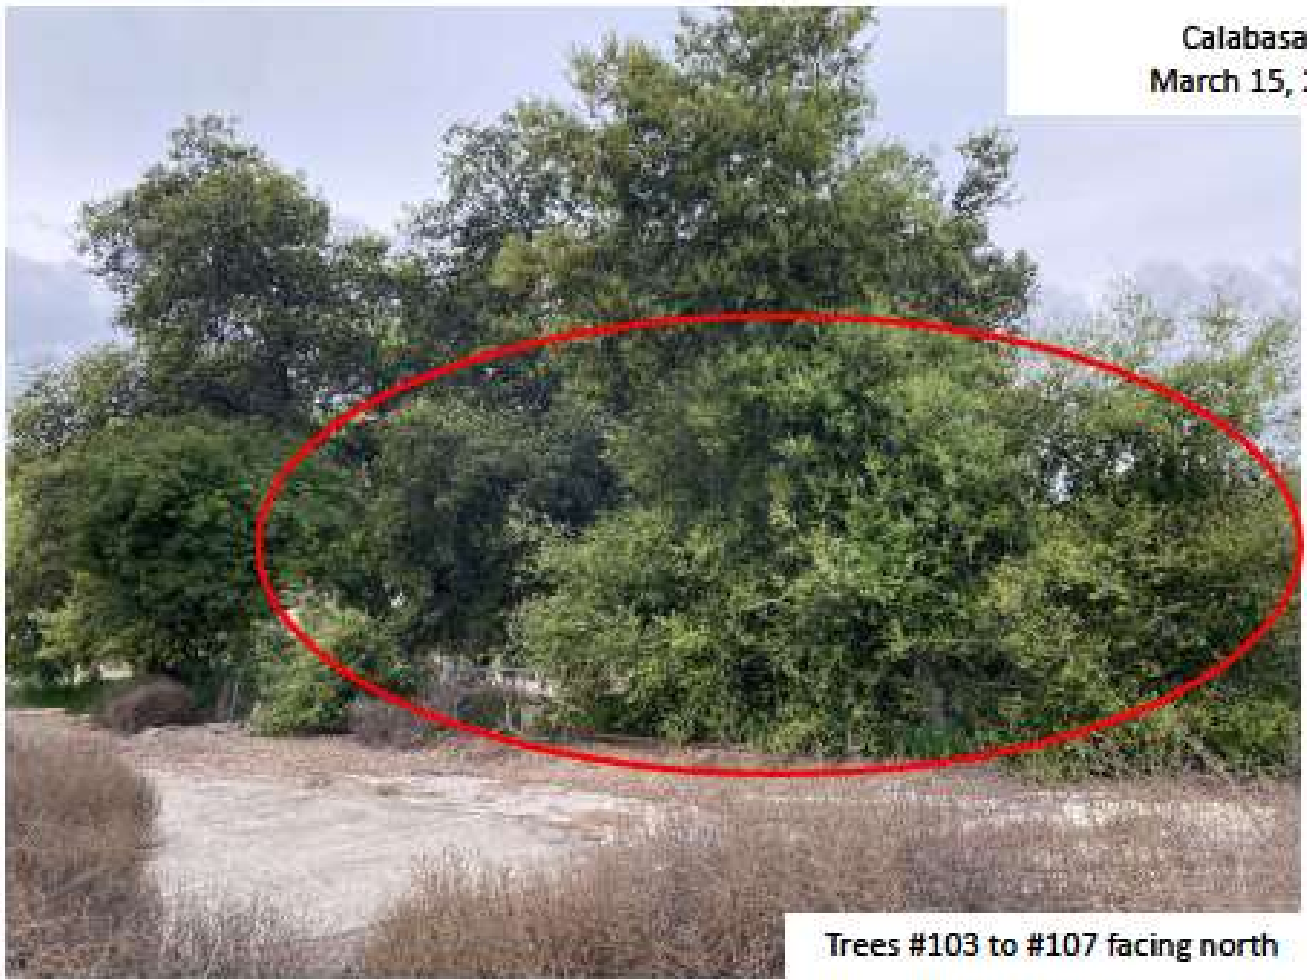
Trees #103 to #107 facing north

Oak trees #103, #104, #105, #106, and #107 – 5 young oak trees are located along the property line and an existing retaining wall. All the trees are 10 feet from the proposed 3-foot retaining wall. Excavation for the retaining will be no closer than 5 feet from the trunks encroaching roughly 10 to 15 percent of the PZs. These trees will be preserved and protected.

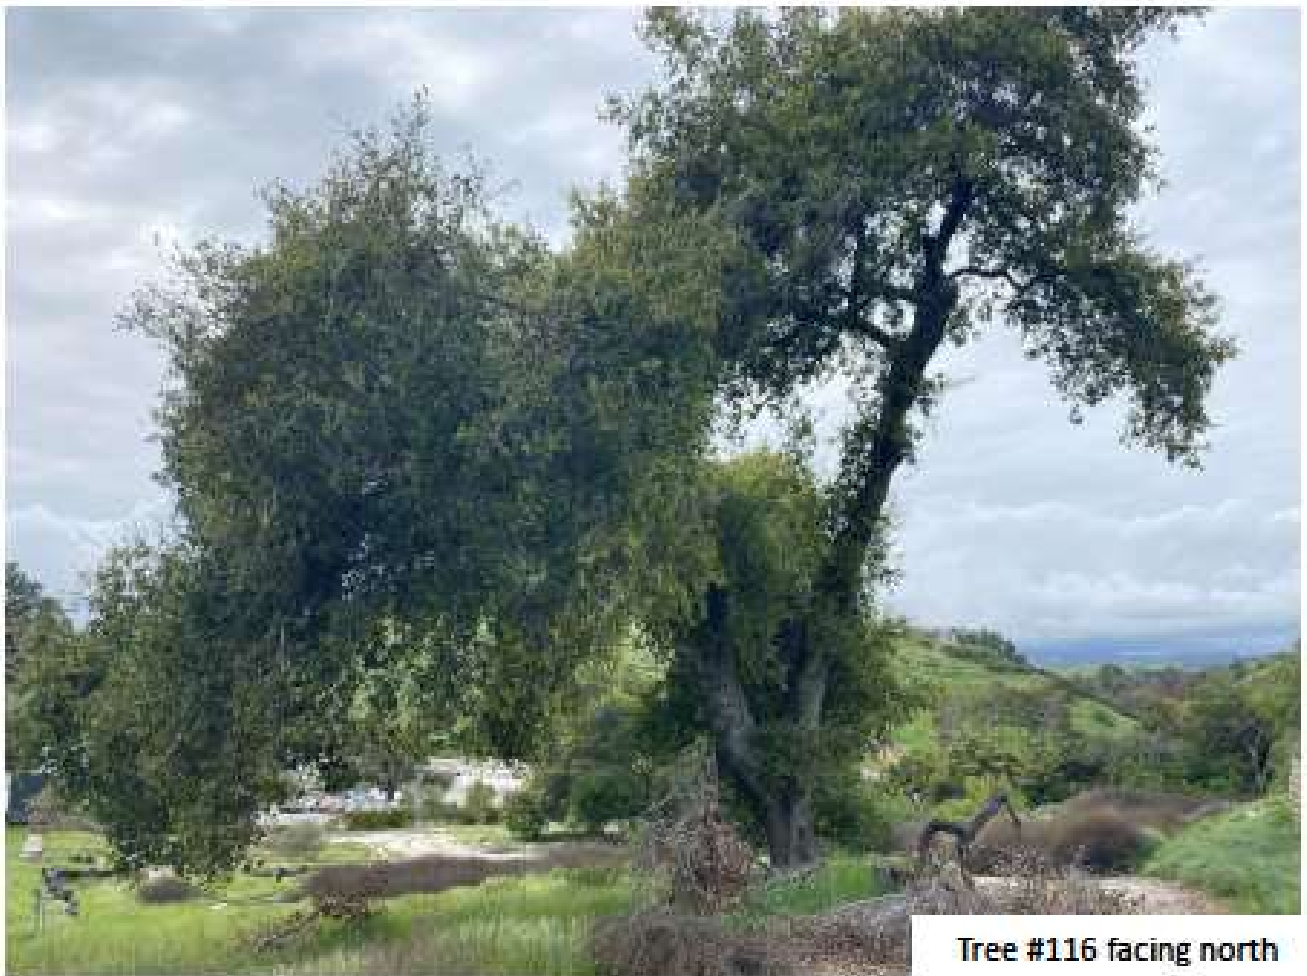
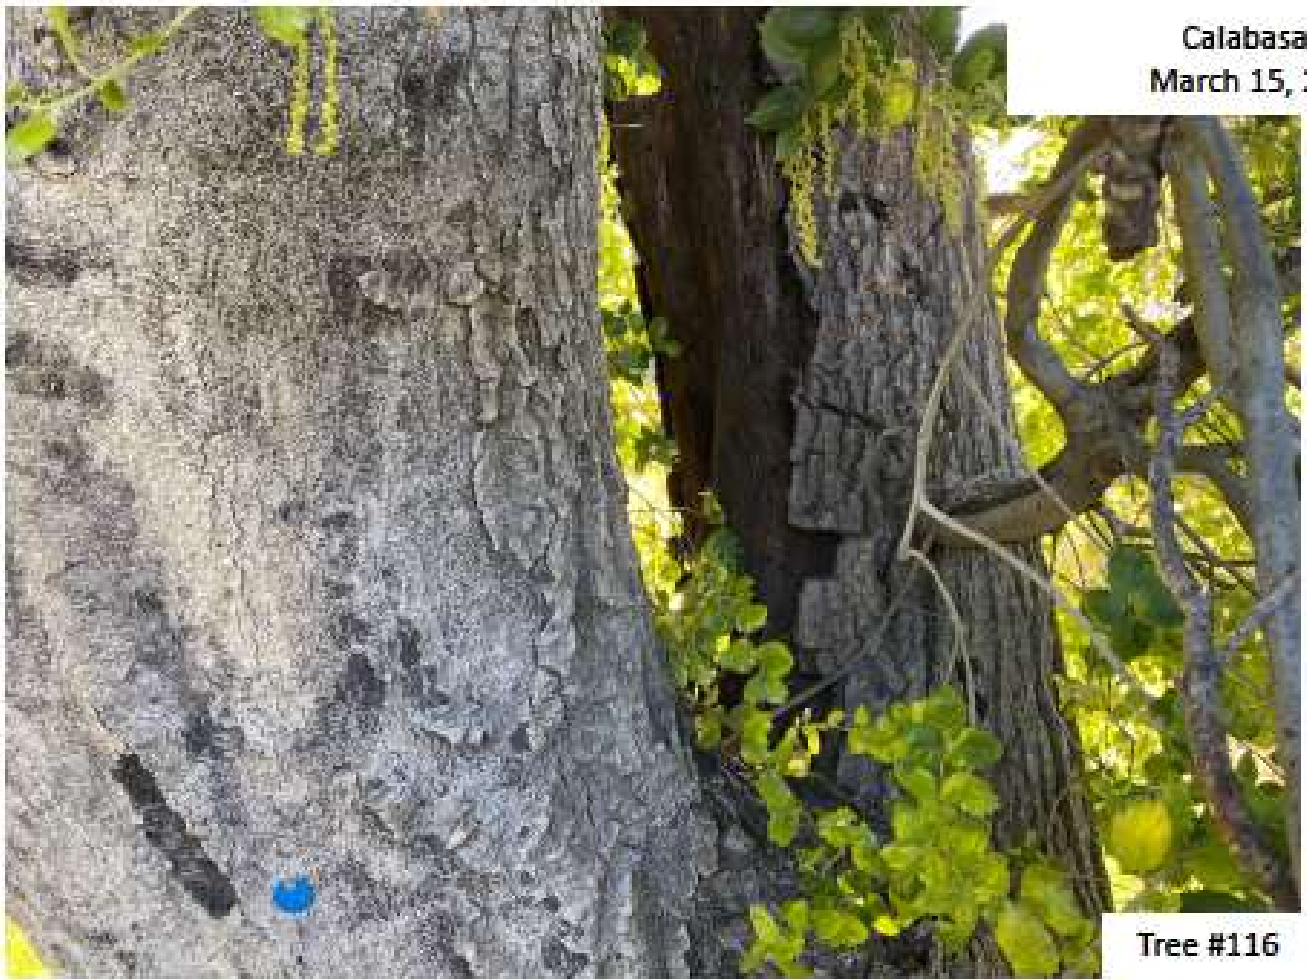
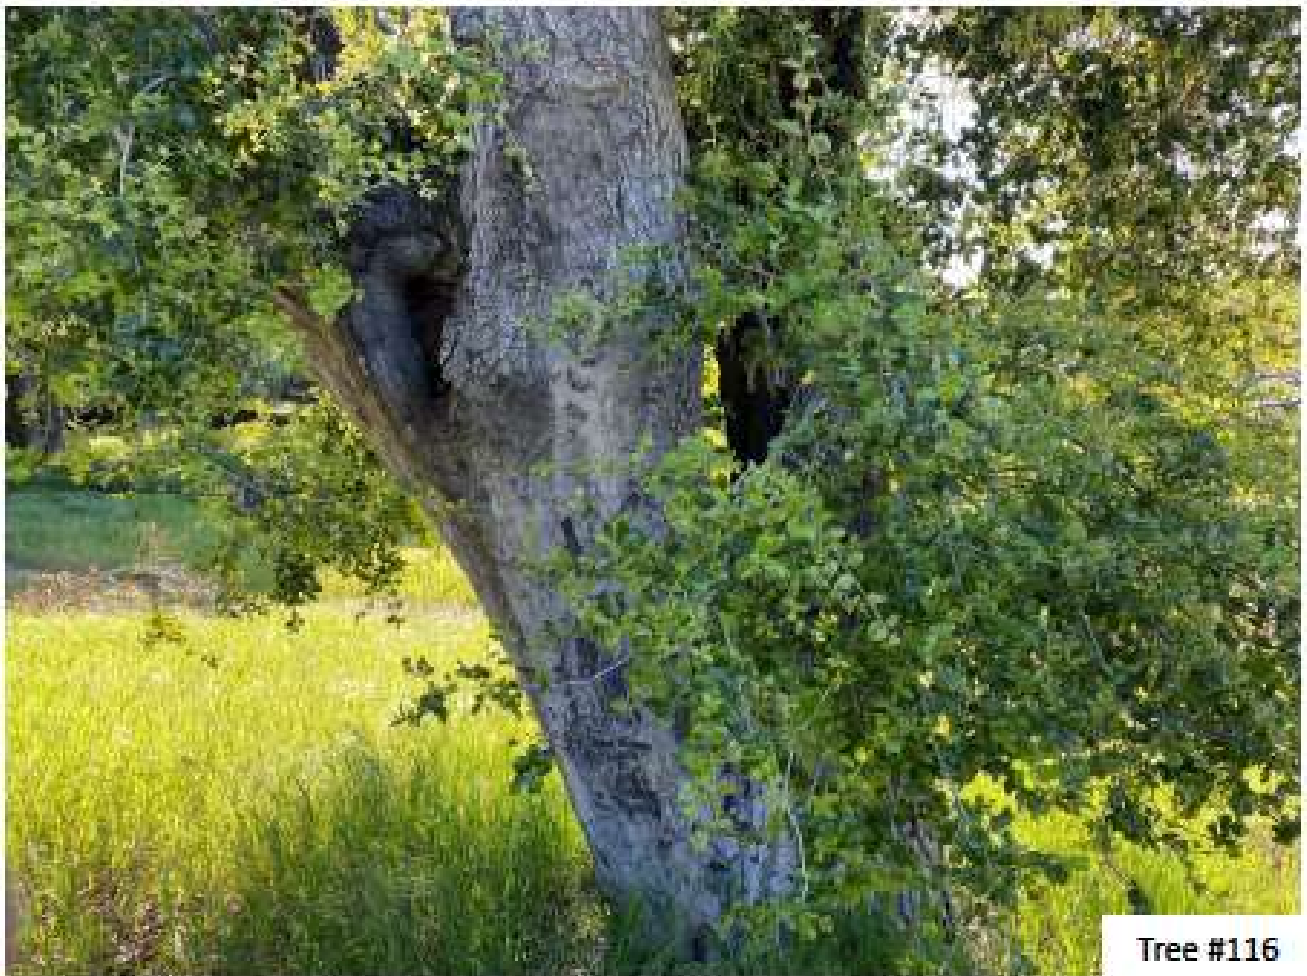
Tree #116 facing north

Oak tree #116 – This tree will be encroached by grading for a parking lot, a debris basin, and an access road to the debris basin. Roughly half of the PZ area will be encroached by grading. Part of the access road is an existing length of a paved road within the PZ. This will be a potentially harmful encroachment due to the removal of existing roots although there will be no encroachment closer than 25 feet from the trunk. This tree is declining structurally and should be evaluated later to determine whether drastic pruning should be done to make it safer. I recommend fencing this tree permanently to restrict access to it or remove it if, with further assessment, it is determined likely to fail and strike a target. This tree should be preserved and protected. No pruning required.

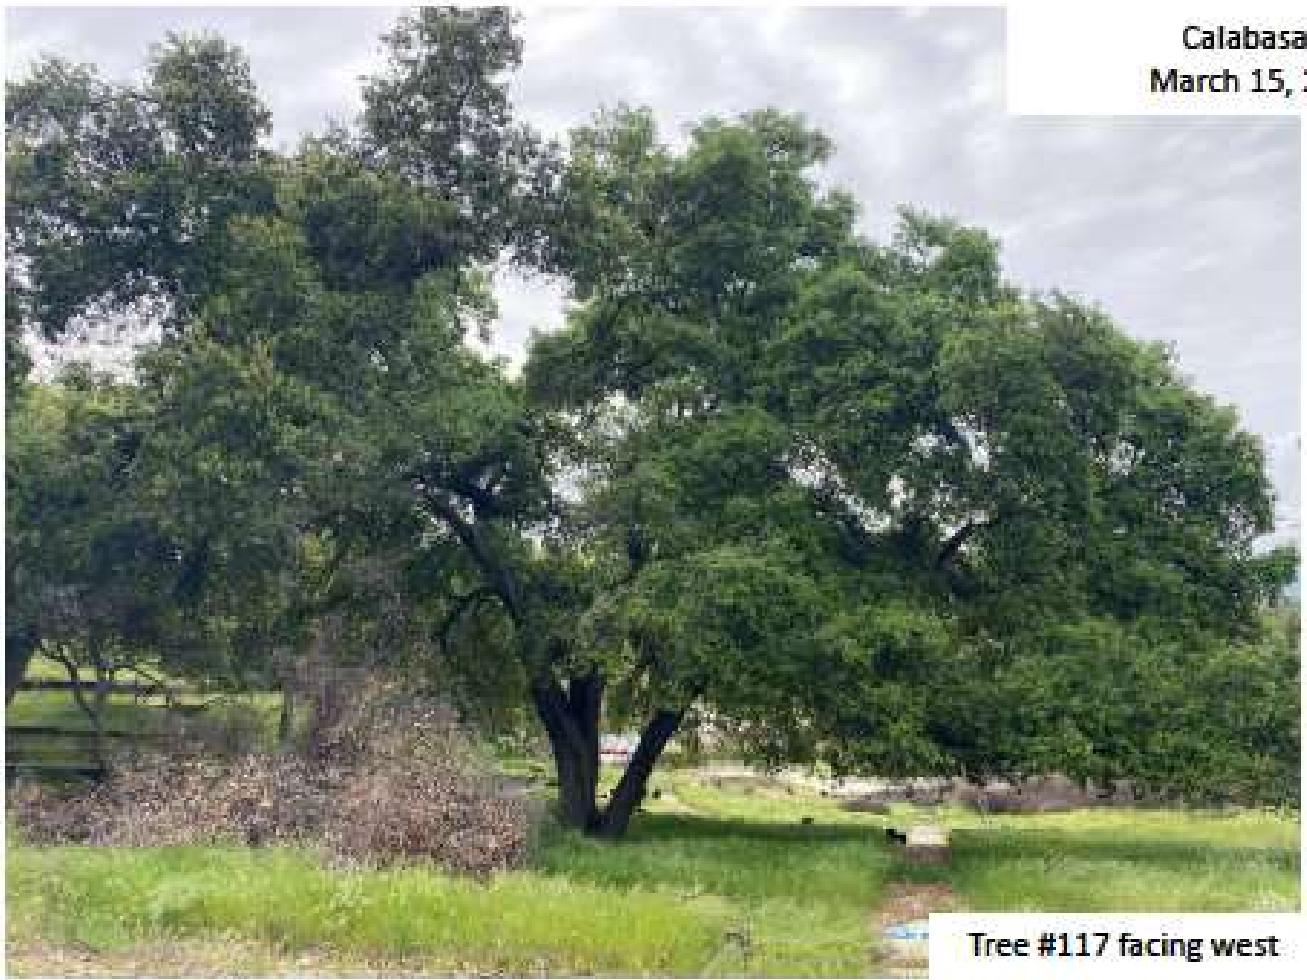
Tree #117 facing west

Oak tree #117 – This tree will be encroached by grading for a parking lot and a manufactured slope. Roughly 25 percent of the PZ area will be encroached by grading. This will be a potentially harmful encroachment due to the removal of existing roots although there will be no encroachment closer than 16 feet from the trunk. This is a healthy tree and the manufactured slope will be a significant encroachment but only on the north side of the tree. This tree should be preserved and protected. No pruning required.

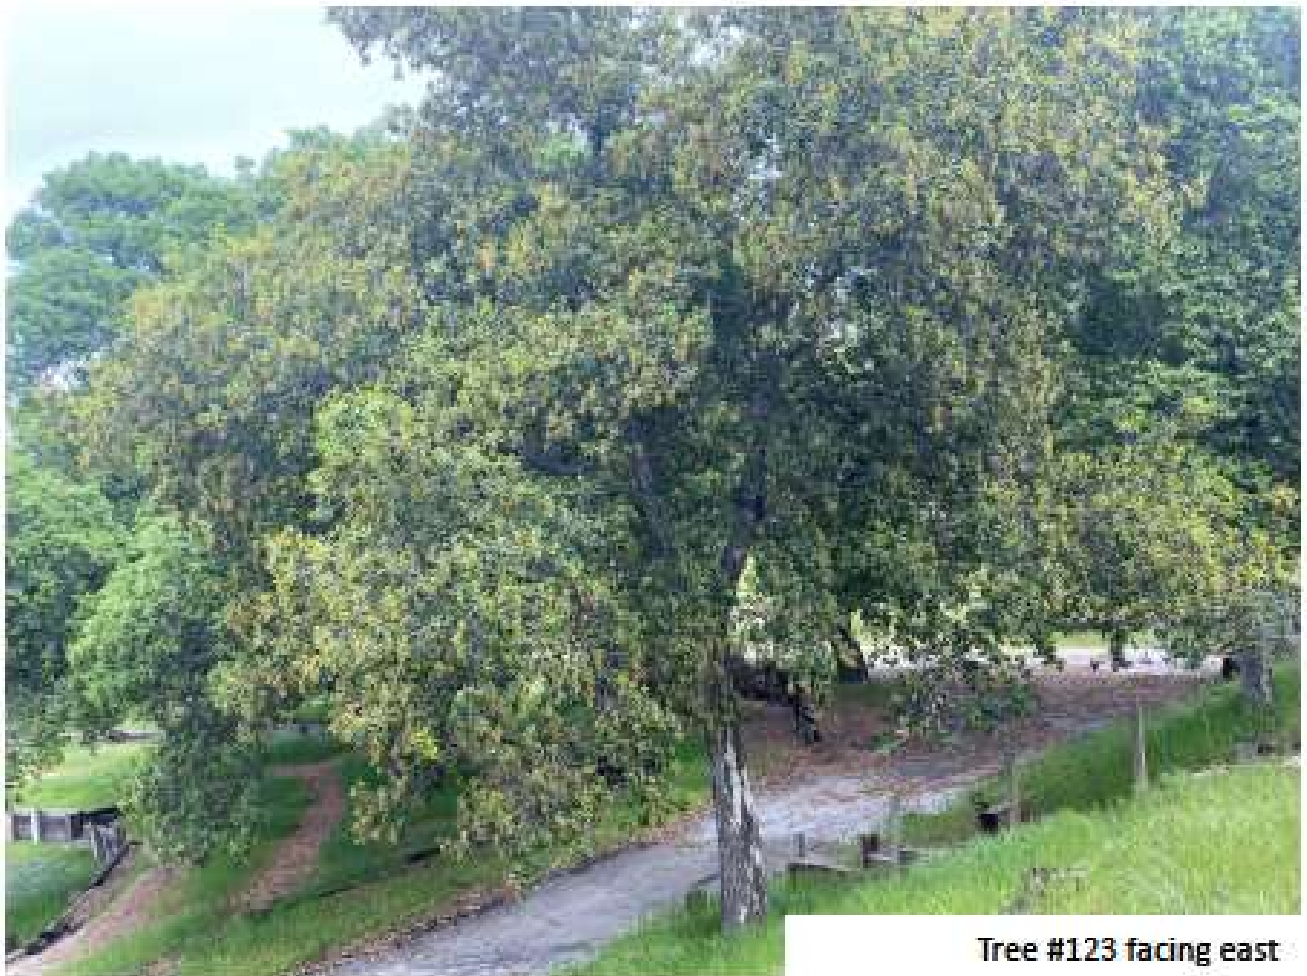
Tree #123 facing east

Oak tree #123 – This tree will be encroached by the manufactured slope to grade the parking lot, impacting 30 percent of the PZ. The v-ditch at the limit of grading will be no closer than 5 feet from the trunk. This will be a significant encroachment that can be managed. This tree will be protected and preserved, and no pruning will be needed.

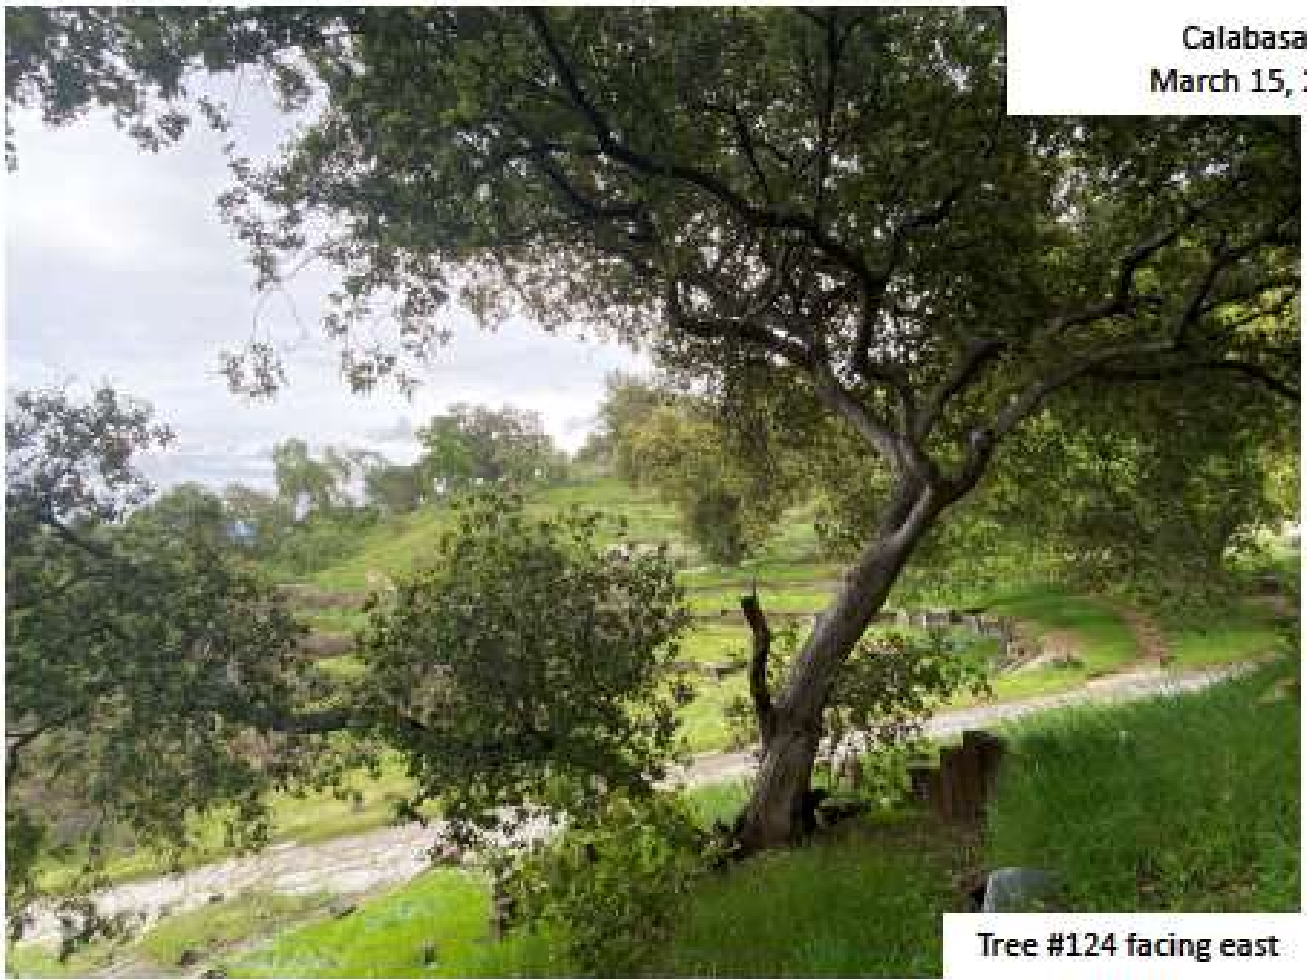
Tree #124 facing east

#124 – encroaches 35 percent of the PZ, no closer than 17 feet from the trunk.

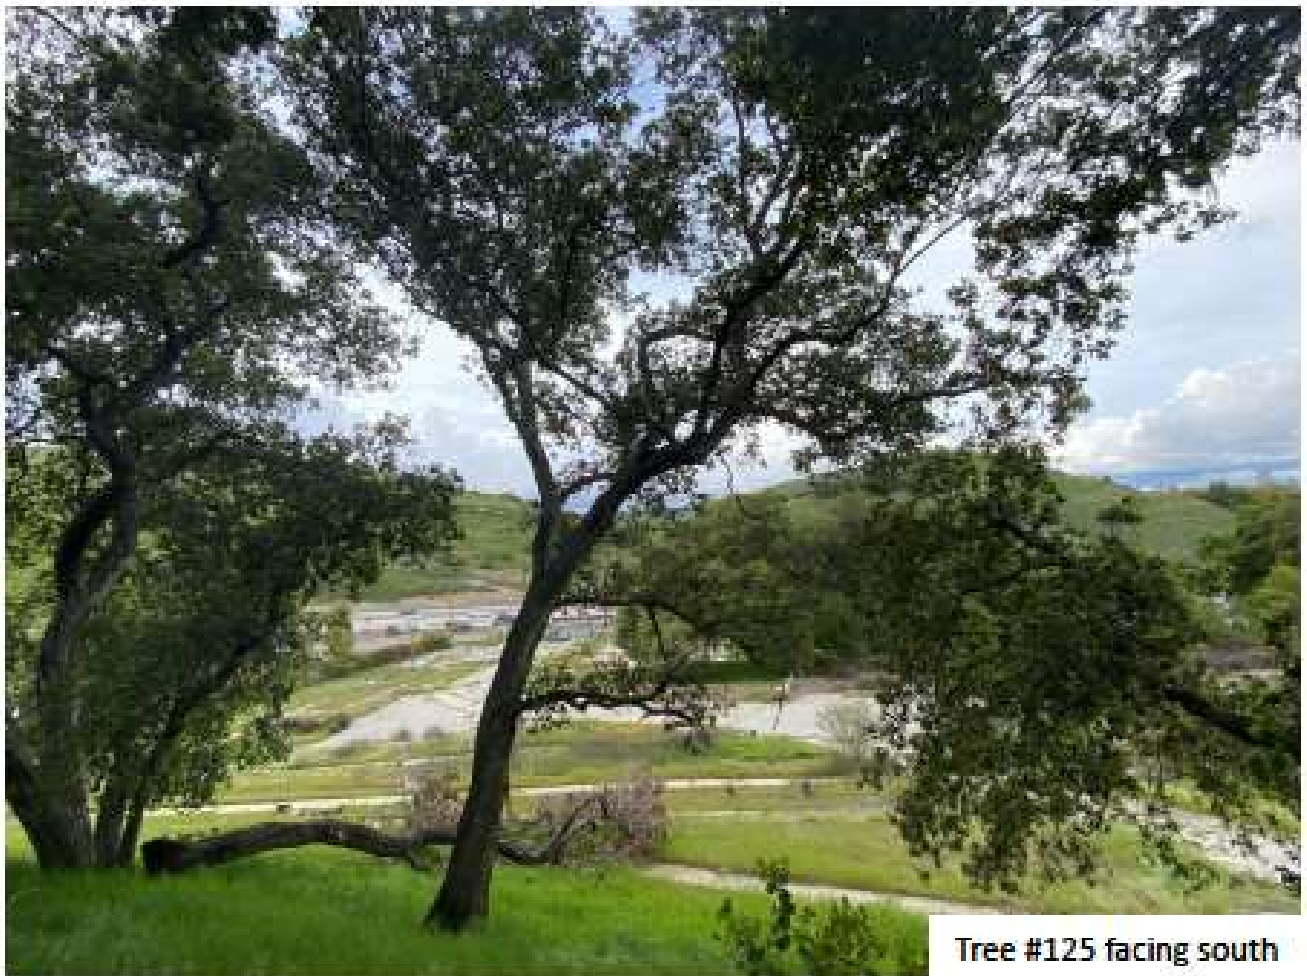
Tree #125 facing south

#125 – encroaches 21 percent of the PZ, no closer than 17 feet from the trunk.

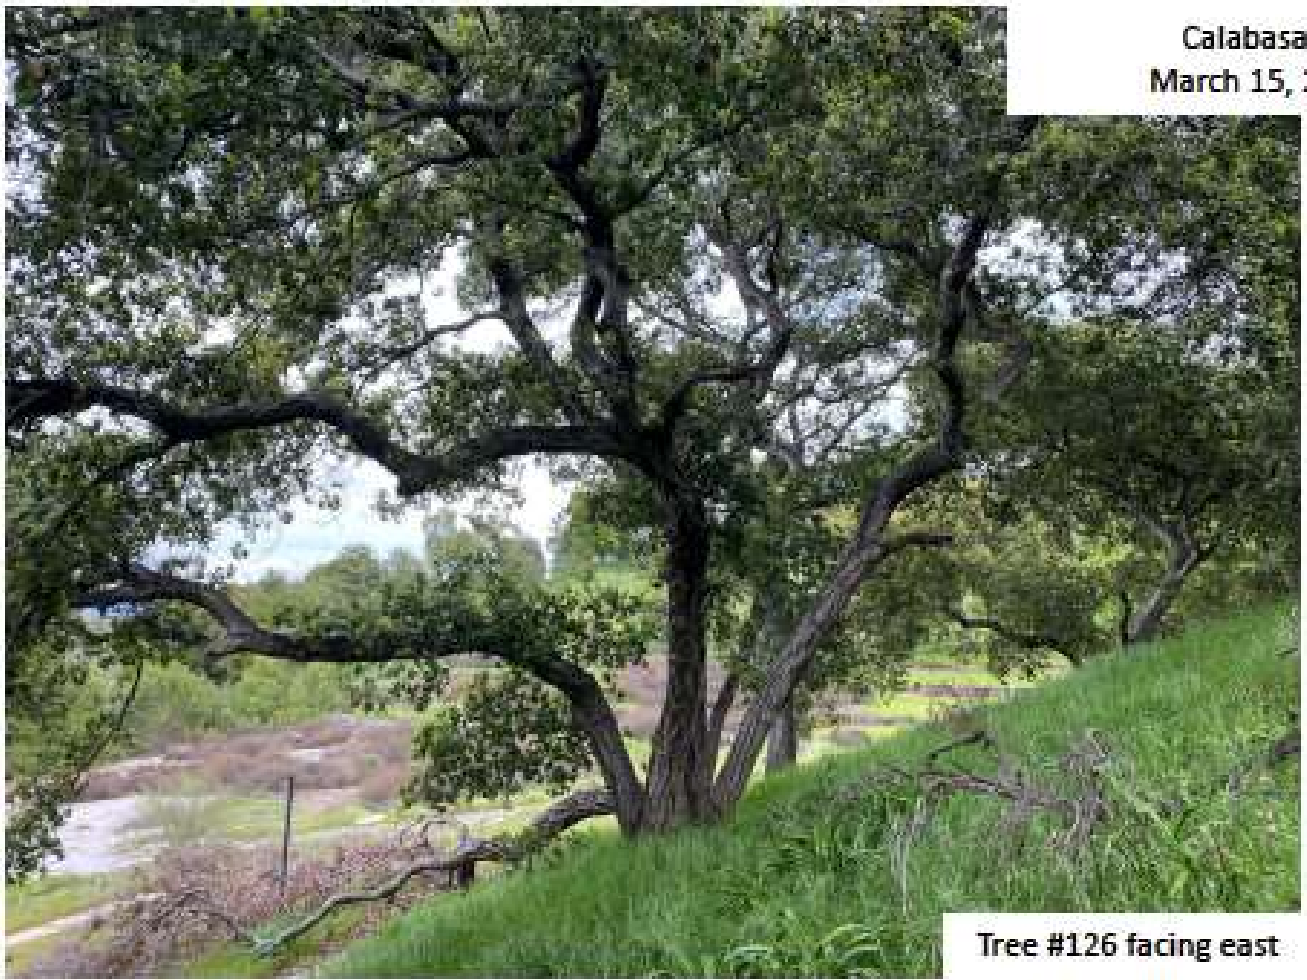
Tree #126 facing east

#126 – encroaches 30 percent of the PZ, no closer than 17 feet from the trunk.

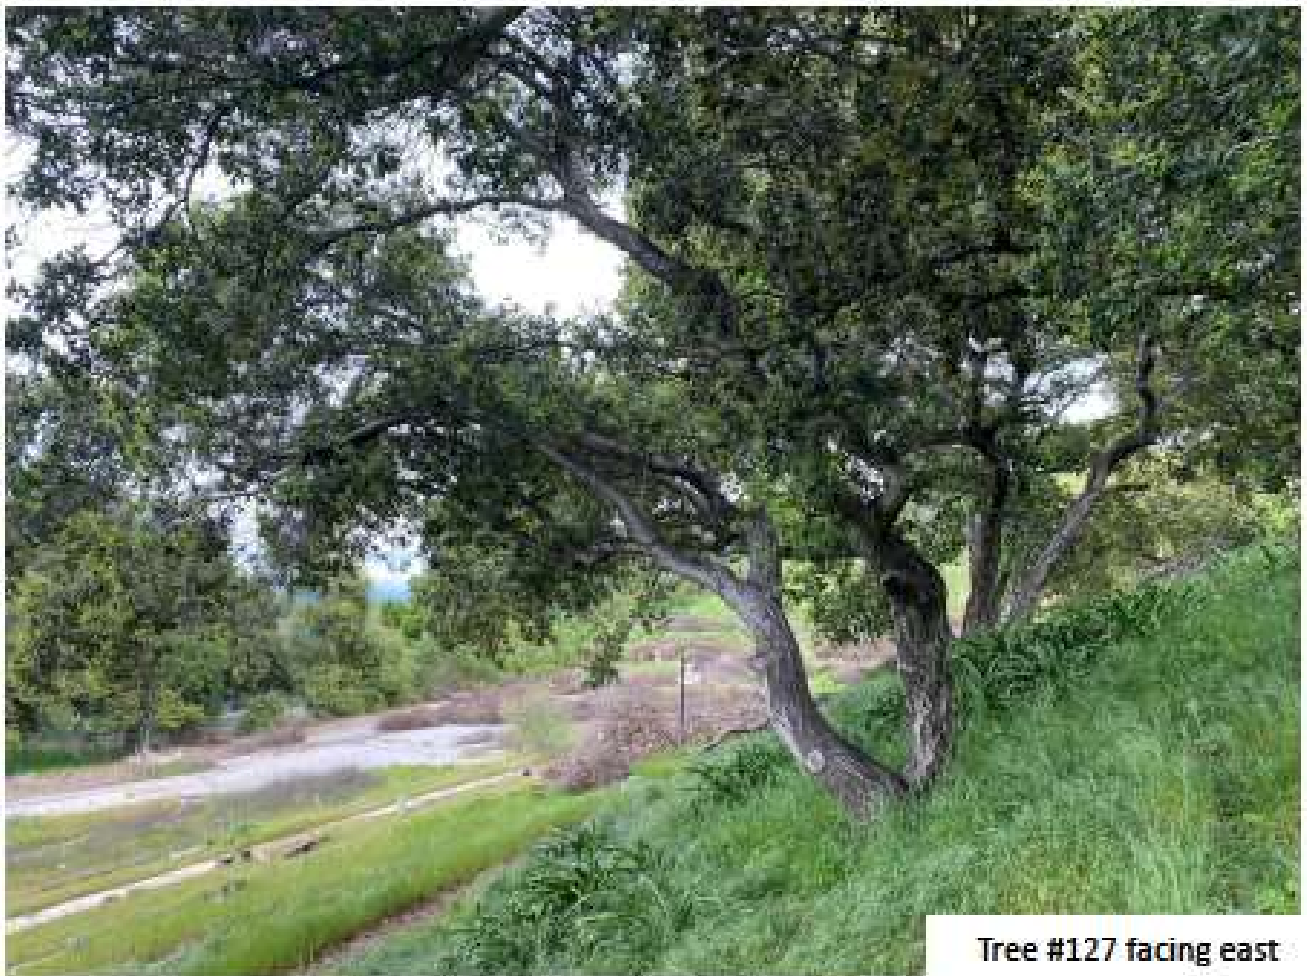
Tree #127 facing east

#127 – encroaches 25 percent of the PZ, no closer than 18 feet from the trunk.

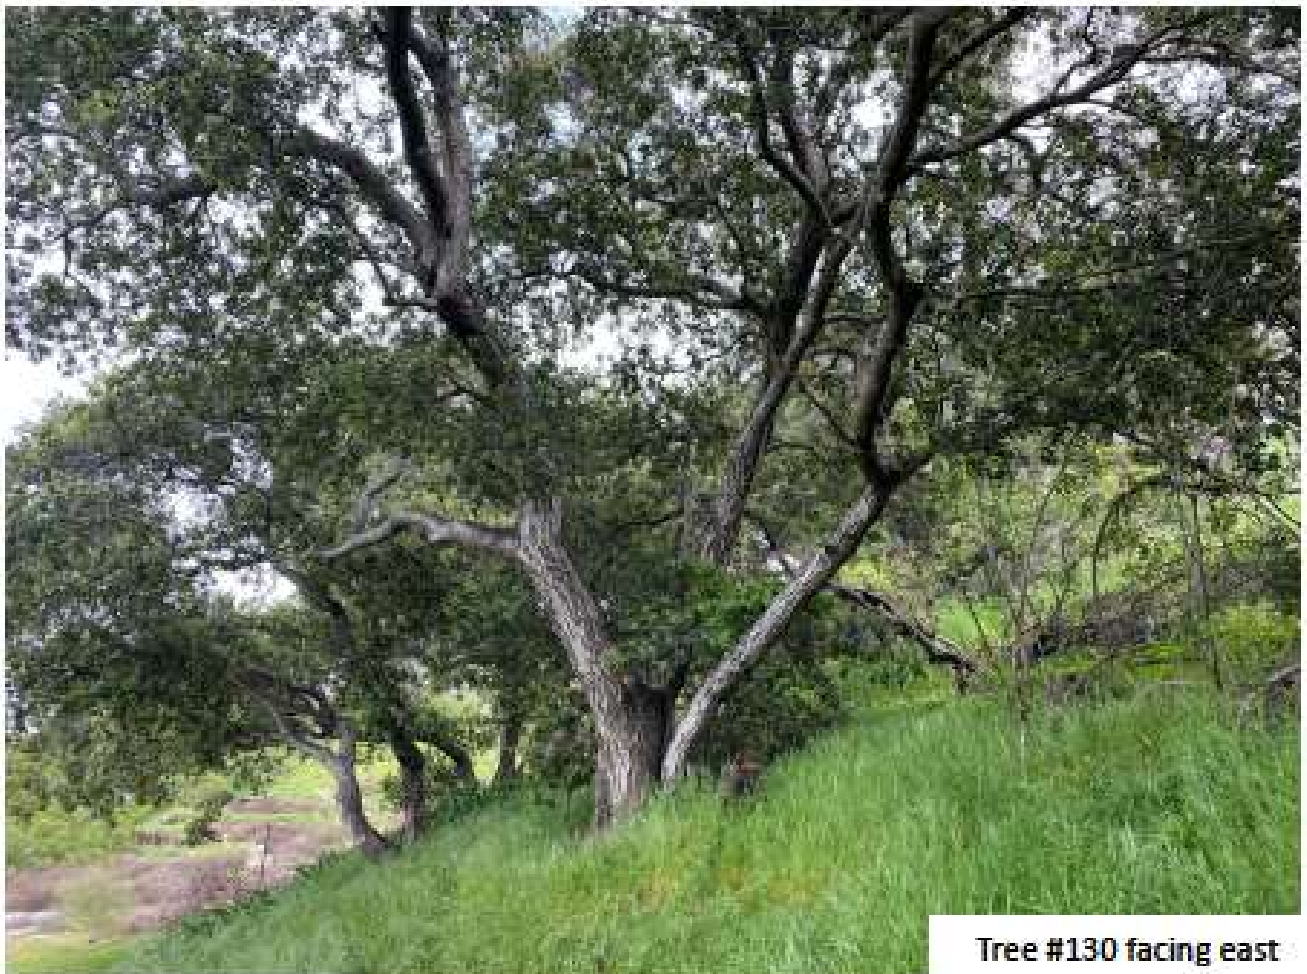
Tree #130 facing east

#130 – encroaches 12 percent of the PZ, no closer than 28 feet from the trunk.

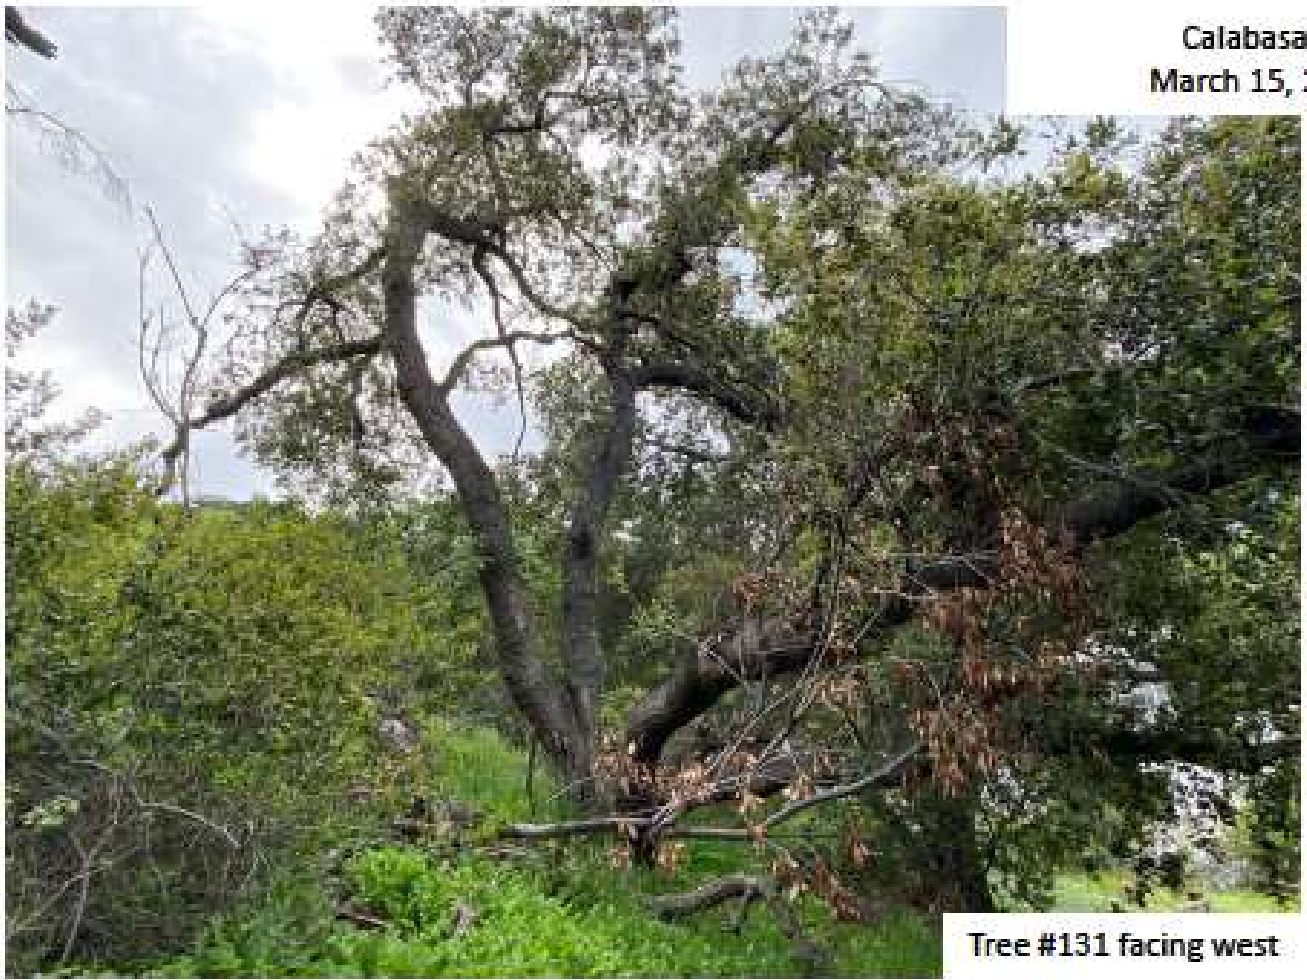
Tree #131 facing west

#131 – encroaches 5 percent of the PZ, no closer than 39 feet from the trunk.

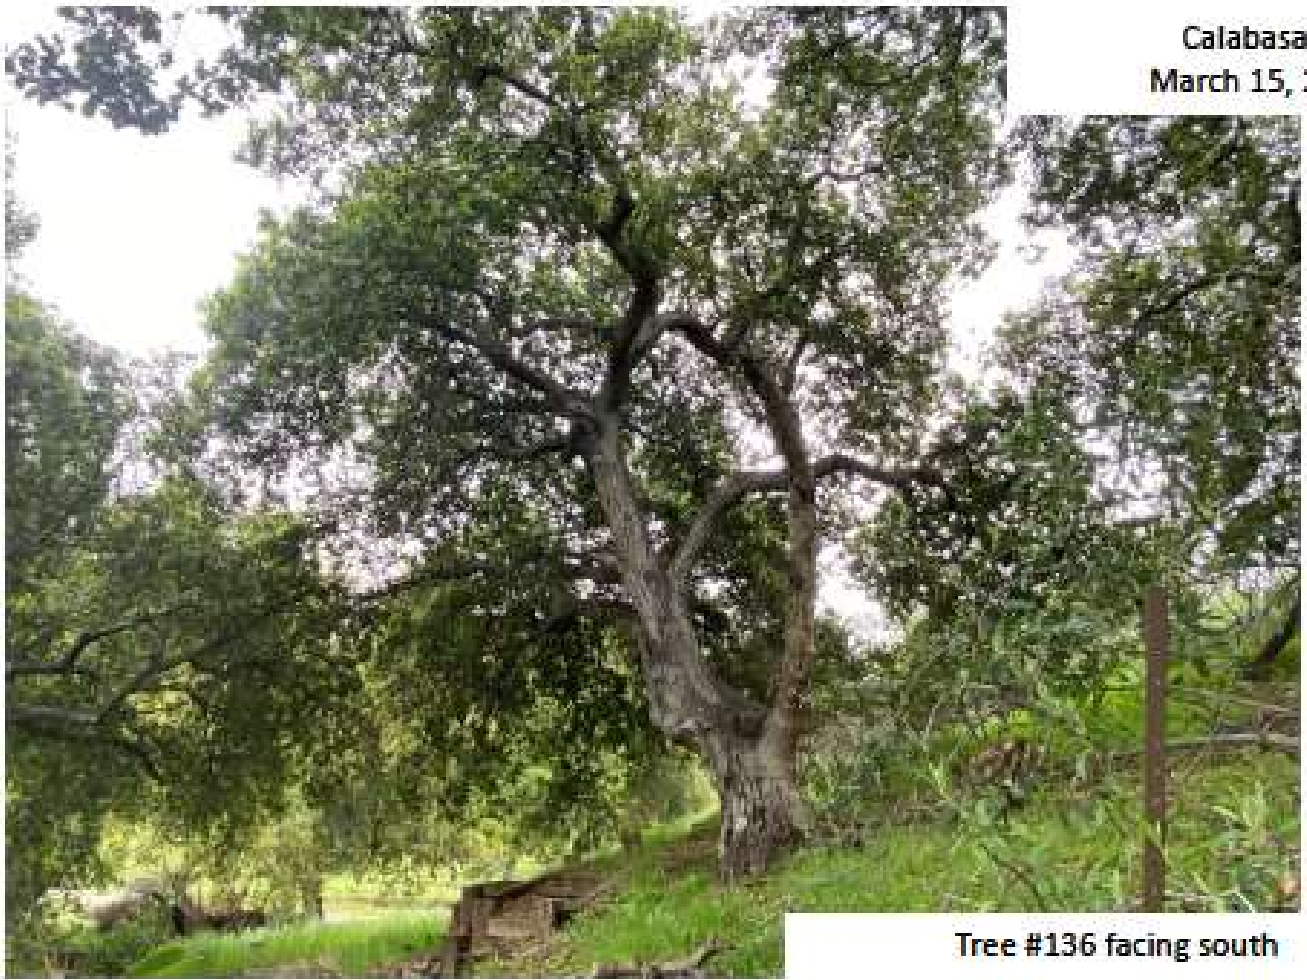
Tree #136 facing south

Oak tree #136 – This tree will be encroached by the v-ditch above the manufactured slope which will impact 3 percent of the PZ and will be no closer than 48 feet from the trunk.

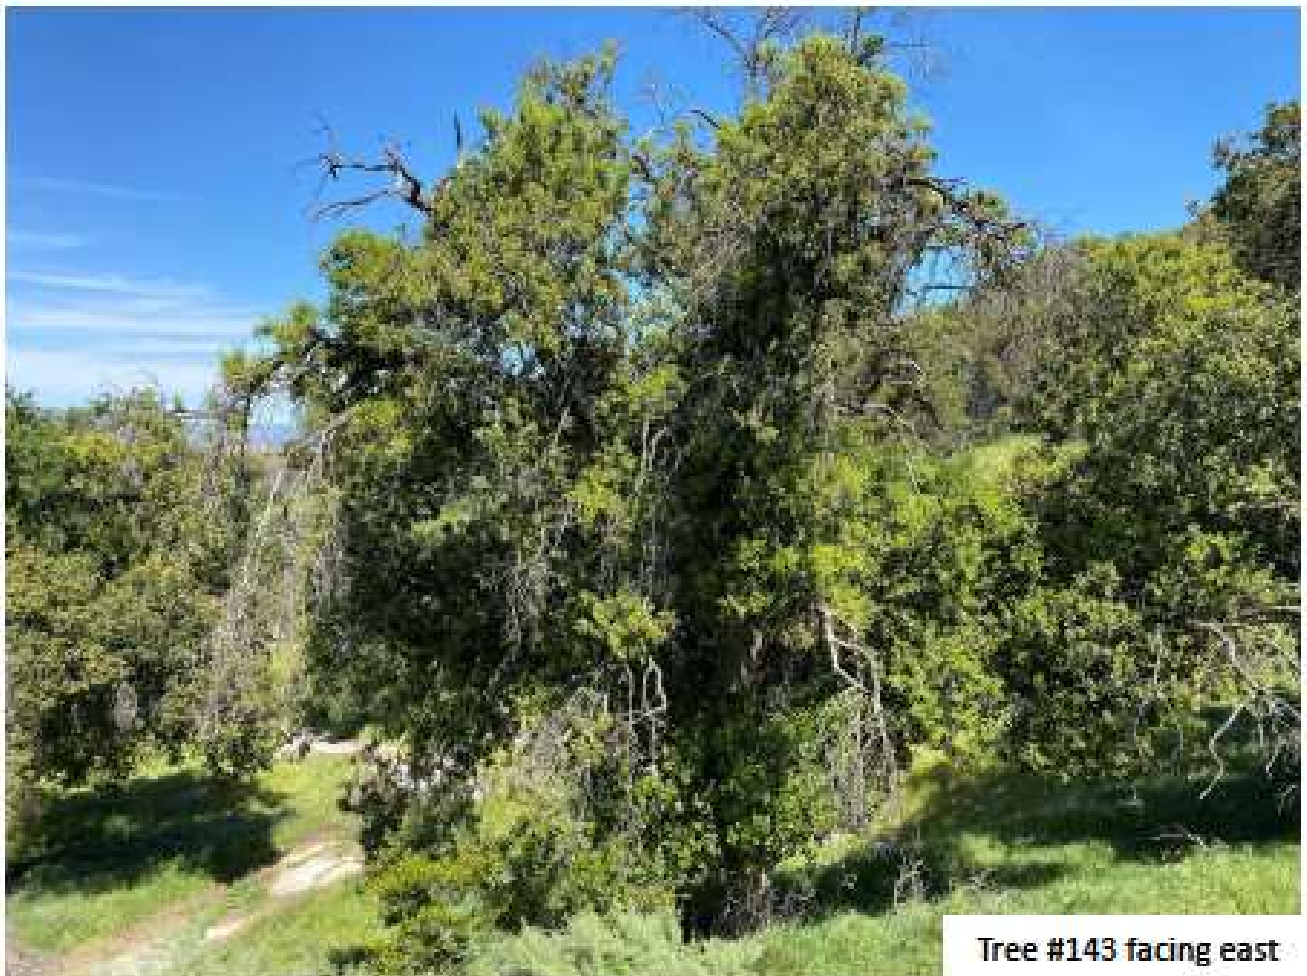
Tree #143 facing east

Oak tree #143 – This tree will be encroached by a drainage channel that begins near this tree, 34 feet from the trunk and encroaching 4 percent of the PZ.

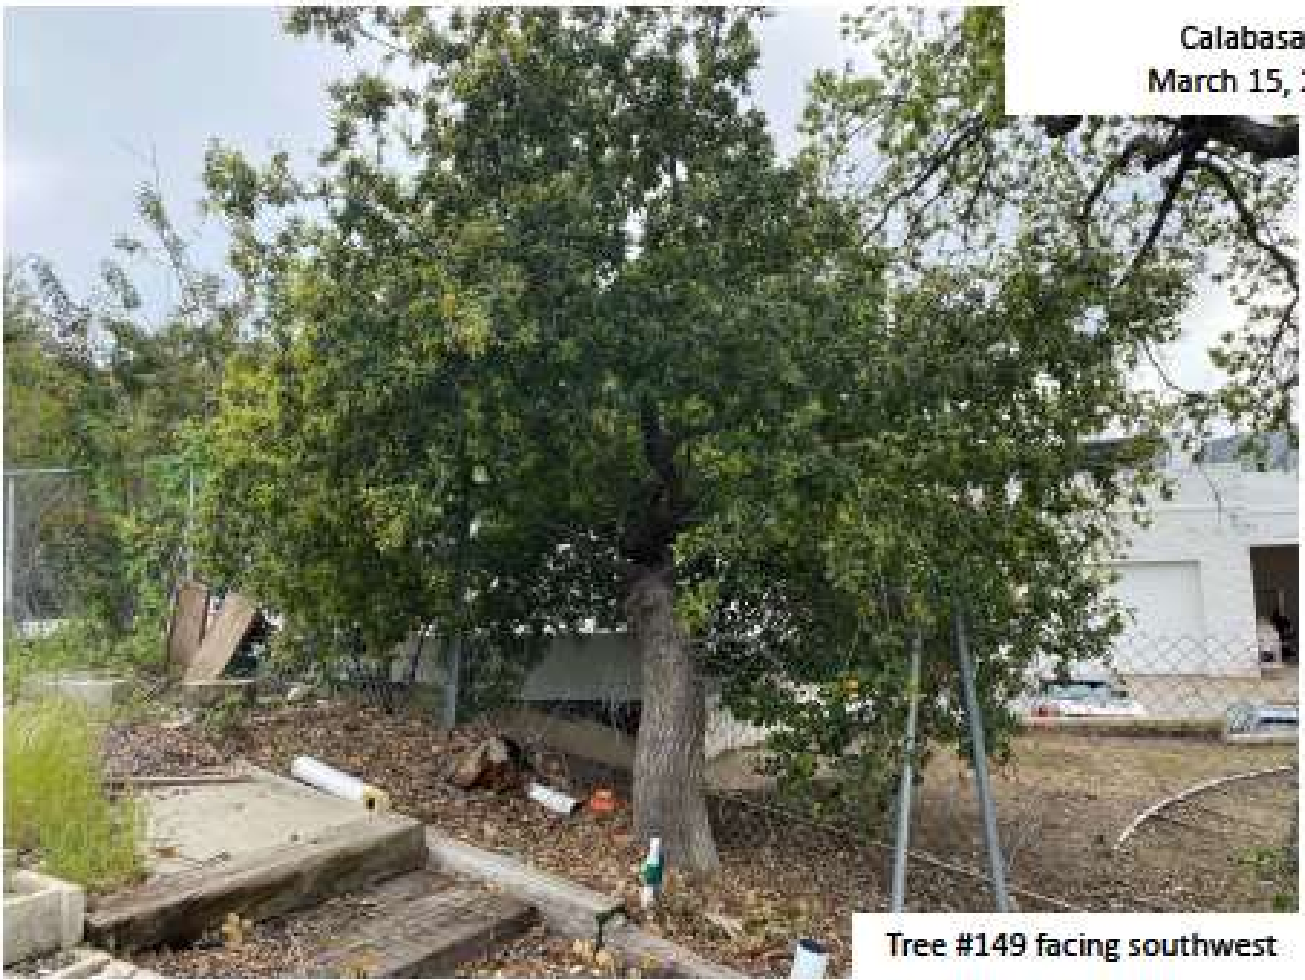
Tree #149 facing southwest

Oak tree #149 – This tree will be encroached by a 4-foot retaining wall, 5 feet from the trunk. This is a severe encroachment that will jeopardize the health of this tree, impacting 50 percent PZ. The drain line shown on the plan will be aligned away from the trunk.
