OAK TREE REPORT

Calabasas Kia

Date: March 31, 2023

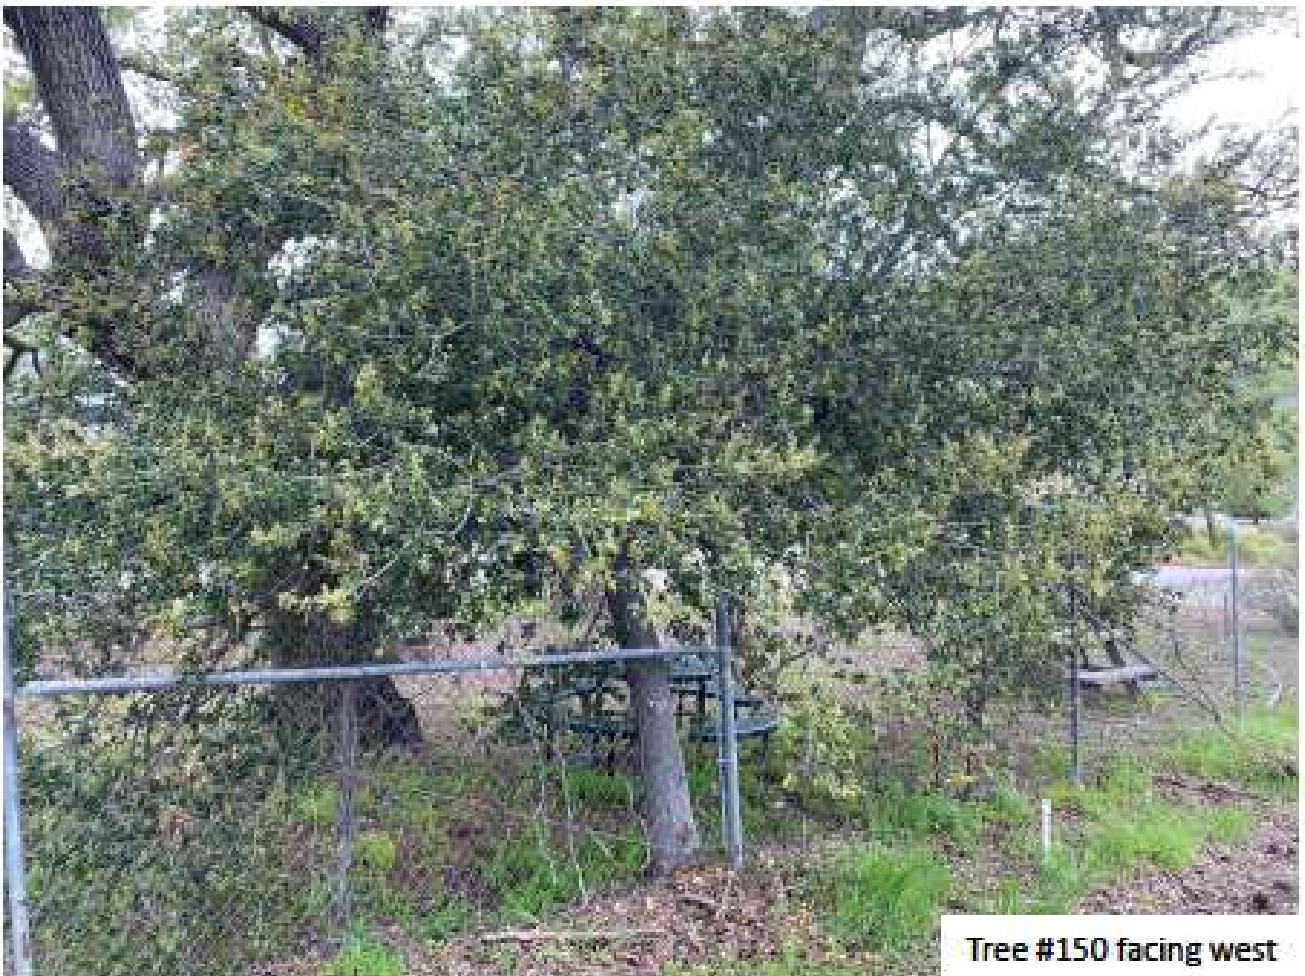
Tree #150 facing west

Oak tree #150 – This tree is located on the west property line, 2 feet from a proposed 6-foot retaining wall. The excavation for the wall will require the removal of this tree.
